EXAMPLES OF VINTAGE/AGEING PROBLEMS WITH ACOUSTIC DIAGNOSTIC

Marc Foata

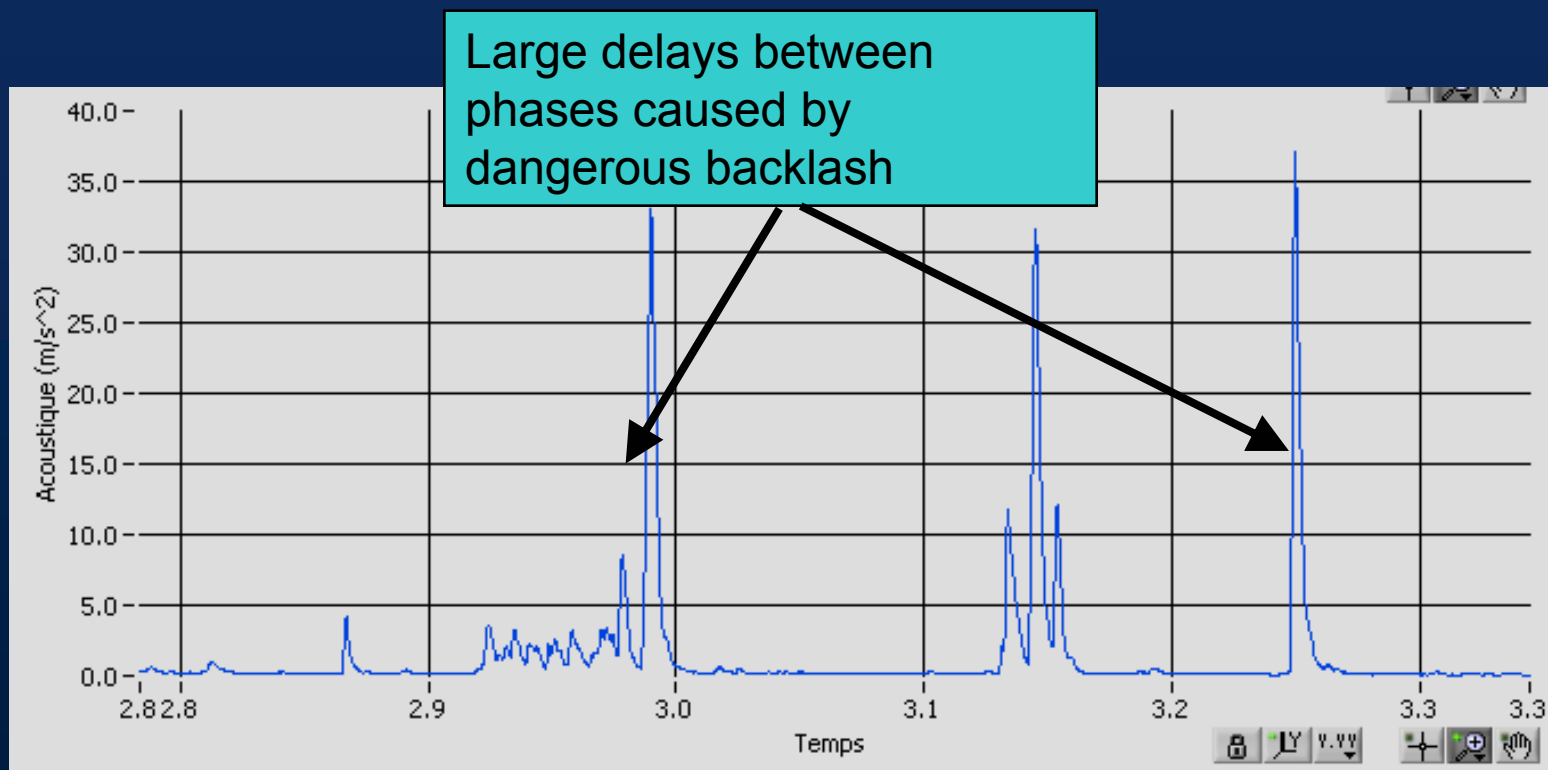
Misaligned Changeover Switch on RT32

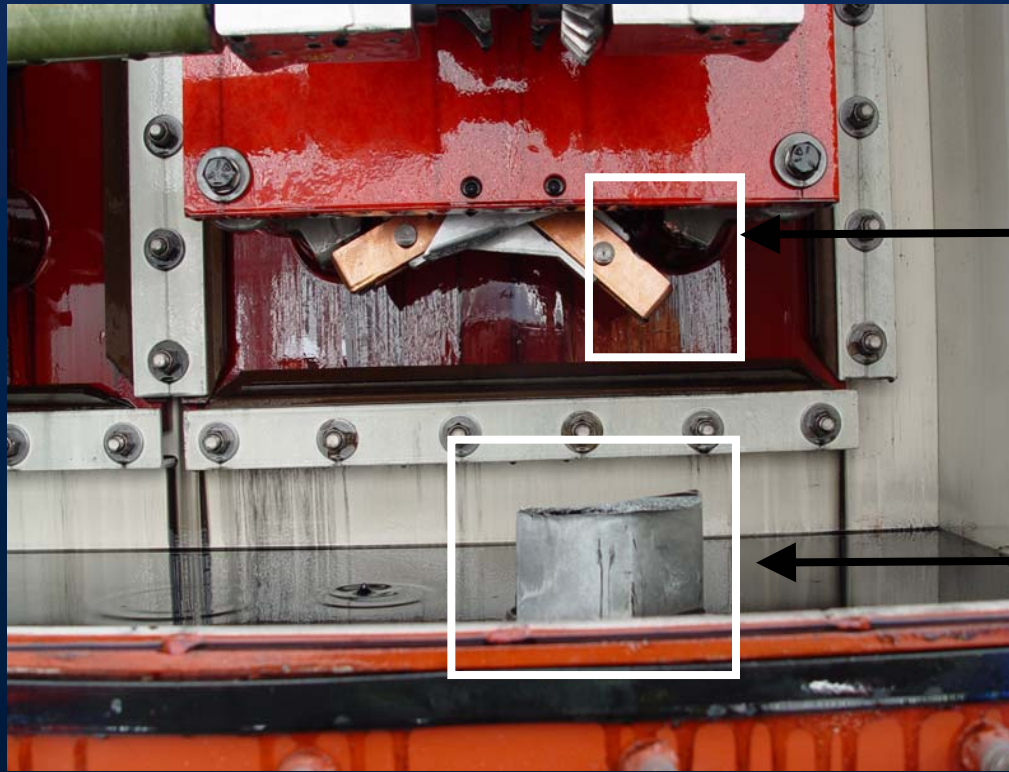
Misaligned Changeover Switch on RT32

Arcing Spots

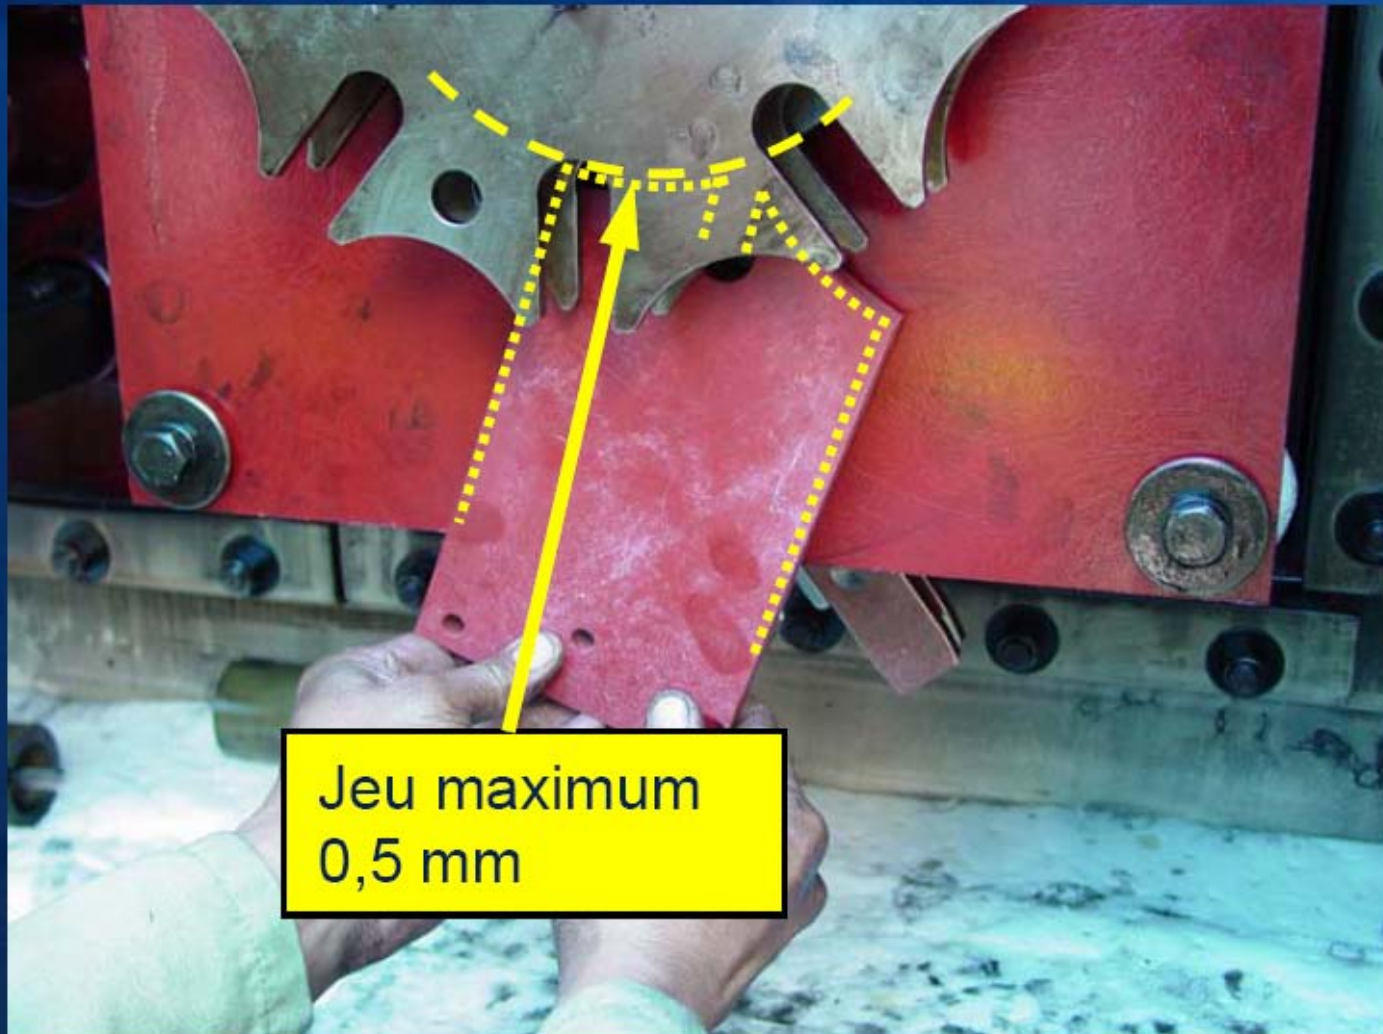
Broken
Changeover
Switch

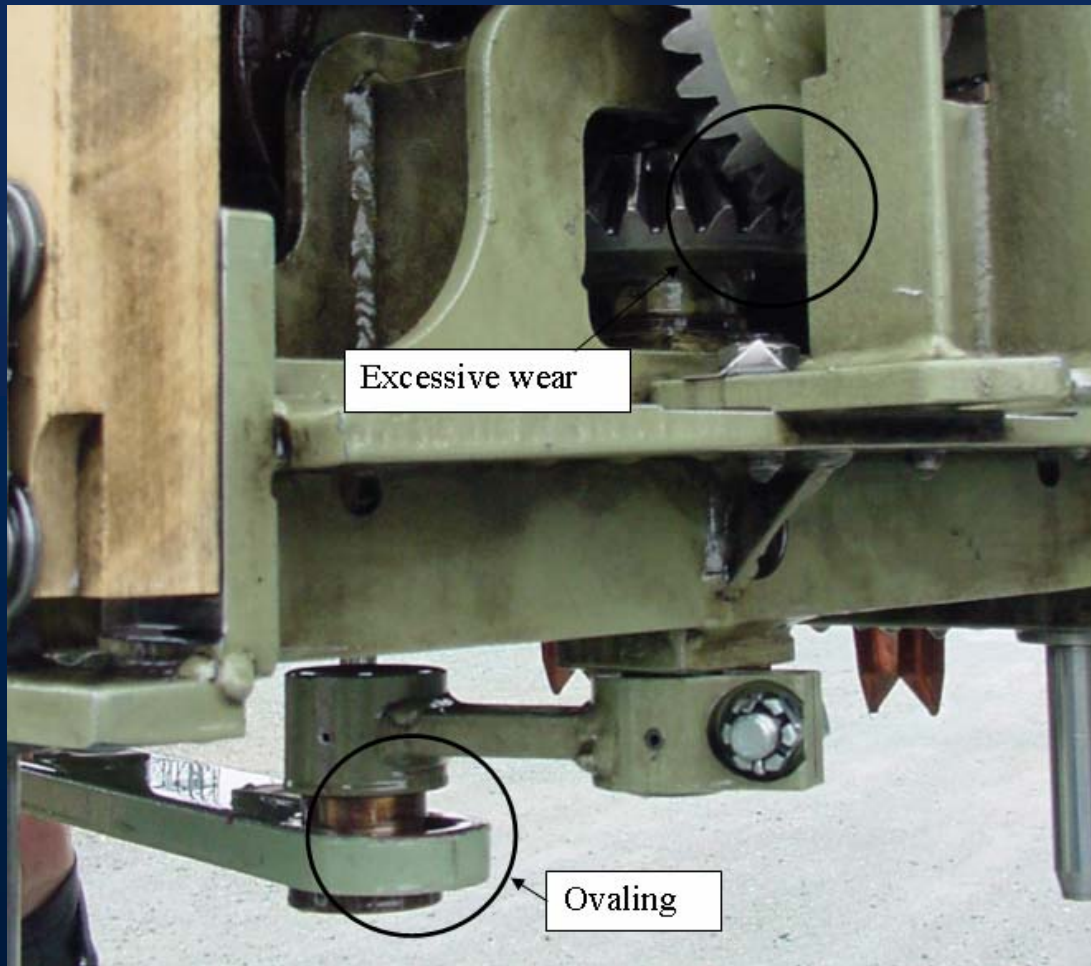
ABB-UCC wear

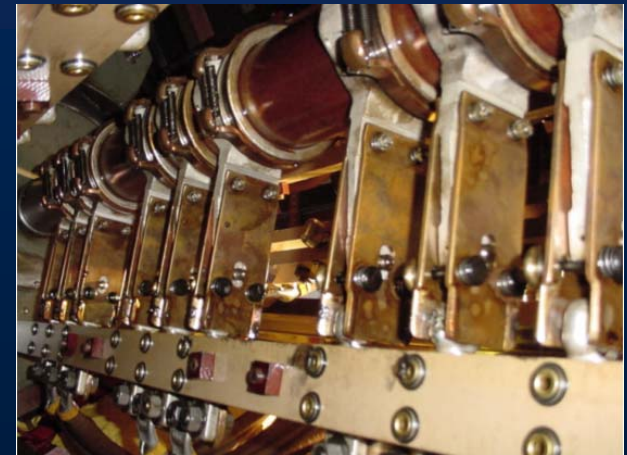
Arcing in selector
